# Access Compliance Report Public Rights-of-Way (Curb Ramps)

| Main Street: ETON_PL | | Cross Street: O_NEILL_DR | | Location: | W |
| ADA ID: RPRK211027120541 | Ramp Type: Type 6 - Directional 1 | Initial Pass/Fail: Fail | Overall Compliance: No | Severity Score: | 16 |

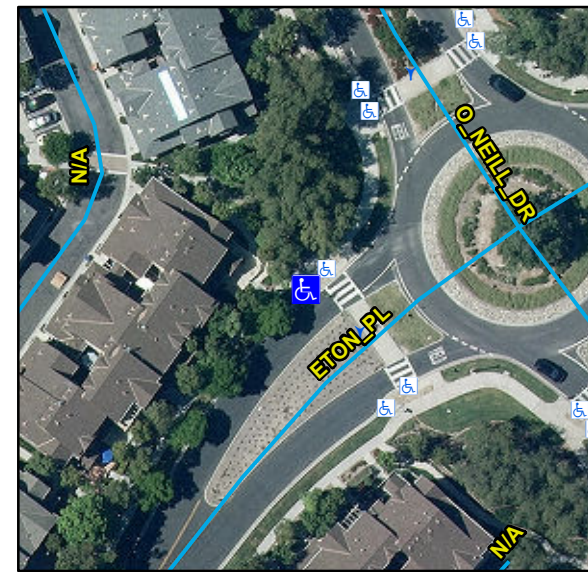
| Compliance | Description | Data | Compliance | Description | Data |
|---|---|---|---|---|---|
| No | Ramp Run Slope (%) | 10.1 | N/A | Flare Slope LT (%) | N/A |
| No | Ramp Cross Slope (%) | 2.4 | N/A | Flare Traversable LT | N/A |
| No | Gutter Lip Height (in) | 0.13 | | Road Run Slope (%) | N/A |

Possible Solutions:

Remove & Replace Entire Ramp. Grind Gutter Lip.

R204.3, R304.2.2, R304.5.3, R302.7.2, STD 1115

Total Cost: \$ 3230
