# Access Compliance Report Public Rights-of-Way (Curb Ramps)

Main Street: ETON\_PL Cross Street: O\_NEILL\_DR Location: N

ADA ID: RPRK211027120930 Ramp Type: Type 6 - Directional 1 Initial Pass/Fail: Pass Overall Compliance: No Severity Score: 16

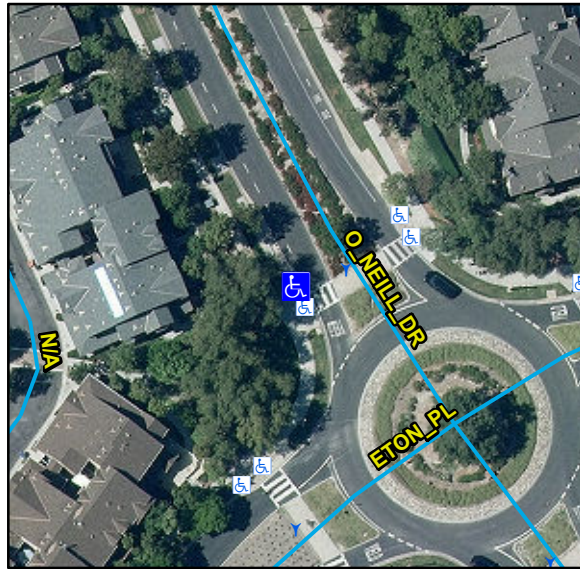
R204.3, R304.5.3, R304.5.2, R304.2.3, R305, R304.5.4, STD 1115

| Compliance | Description | Data | Compliance | Description | Data |
|---|---|---|---|---|---|
| N/A | Ramp Length (in) | 114 | No | Flare Type LT | |
| No | Grade Break | No | Yes | Flare Type RT | |
| | Addl Para Ramp Right? | No | No | DWS Provided | No |
| No | Landing Cross Slope (%) | 3 | N/A | DWS Left Offset (in) | N/A |
| No | Gutter Run Slope (%) | 5.2 | | Road Cross Slope (%) | N/A |

Remove & Replace Entire Ramp. Remove & Replace Gutter.

Total Cost: \$ 3332
