# Access Compliance Report Public Rights-of-Way (Curb Ramps)

| Main Street: O_NEILL_DR | | Cross Street: ETON_PL | | Location: | N |
| ADA ID: RPRK211027121437 | Ramp Type: Type 6 - Directional 1 | Initial Pass/Fail: Fail | Overall Compliance: No | Severity Score: | 2 |

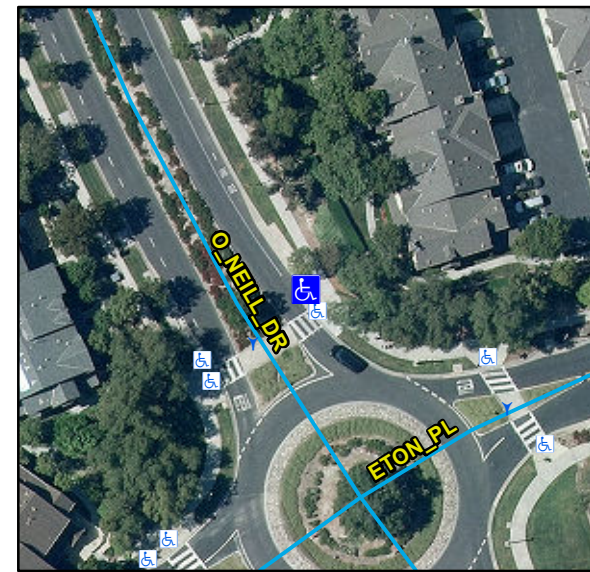
| Compliance | Description | Data | Compliance | Description | Data |
|---|---|---|---|---|---|
| No | Ramp Cross Slope (%) | 3.6 | N/A | Flare Traversable LT | N/A |

Possible Solutions:

Remove & Replace Entire Ramp.

R204.3, R304.5.3, STD 1115
