# Access Compliance Report Public Rights-of-Way (Curb Ramps)

| Main Street: O_NEILL_DR | | Cross Street: ETON_PL | | Location: | NE |
| ADA ID: RPRK211027121901 | Ramp Type:Type 1 - Perpendicular | Initial Pass/Fail: Fail | Overall Compliance: No | Severity Score: | 15 |

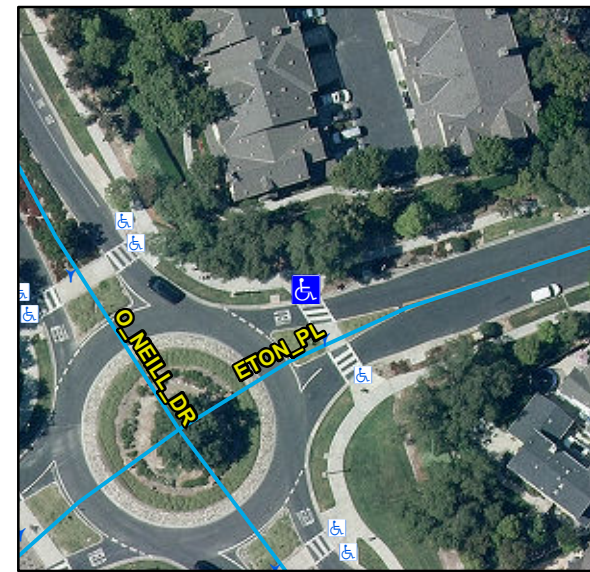
| Compliance | Description | Data | Compliance | Description | Data |
|---|---|---|---|---|---|
| No | Ramp Run Slope (%) | 9.1 | N/A | Flare Slope LT (%) | N/A |

Possible Solutions:

**Remove & Replace Entire Ramp.**

**R204.3, R304.2.2, STD 1115**

Total Cost: \$ 3080
