# Access Compliance Report Public Rights-of-Way (Curb Ramps)

Main Street: N/A Cross Street: NARROW\_CANYON\_RD Location: SW

ADA ID: RPRK211027122723 Ramp Type: Type 4 - Parallel Initial Pass/Fail: Pass Overall Compliance: No Severity Score: 26

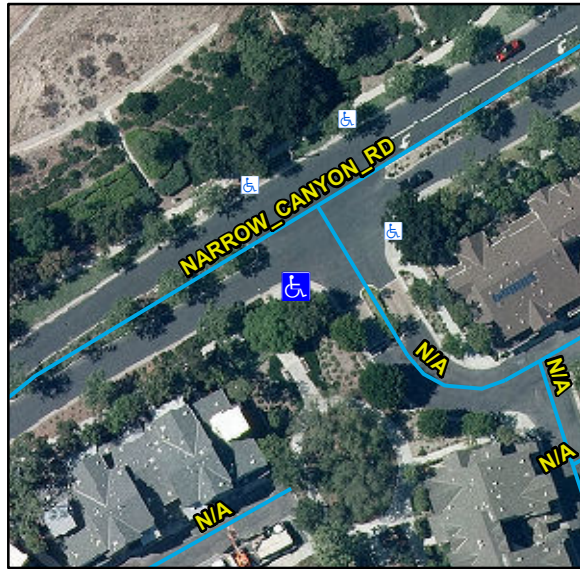
| Compliance | Description | Data | Compliance | Description | Data |
|---|---|---|---|---|---|
| No | Ramp Cross Slope LT (%) | 2.3 | Yes | Ramp Cross Slope RT (%) | 0.5 |
| No | Landing Width (in) | N/A | N/A | DWS Length (in) | N/A |
| No | Landing Run Slope (%) | N/A | N/A | DWS Full Width | N/A |
| No | Landing Cross Slope (%) | N/A | | DWS Offset Type | N/A |
| No | Gutter Run Slope (%) | 12.1 | | Road Cross Slope (%) | 2.4 |
| No | Gutter Cross Slope (%) | 3.2 | No | Perpendicular Joint Present | No |

Remove & Replace Curb Ramp With Two New Directional Ramps or Equivalent. Remove & Replace Gutter.

R204.3, R304.5.3, R304.2.1, R304.2.2-Perp, R304.3.2-Para, R305, R304.5.4, STD 1115
