# Access Compliance Report Public Rights-of-Way (Curb Ramps)

Main Street: **NARROW\_CANYON\_RD** Cross Street: **N/A** Location: **SE**

ADA ID: **RPRK211027122951** Ramp Type: **Type 4 - Parallel** Initial Pass/Fail: **Fail** Overall Compliance: **No** Severity Score: **2**

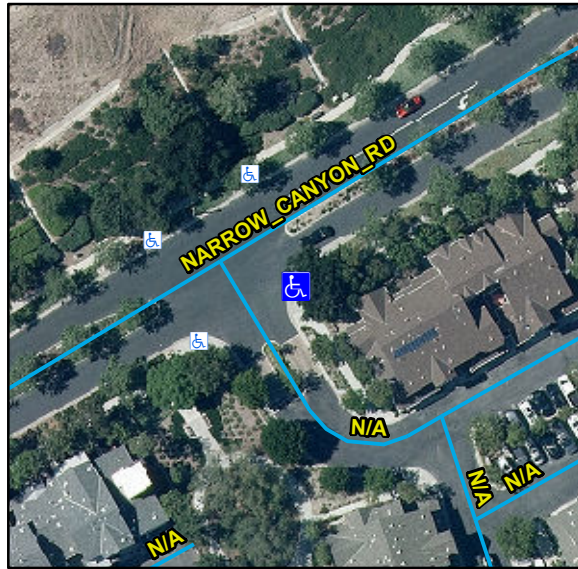
| Compliance | Description | Data | Compliance | Description | Data |
|---|---|---|---|---|---|
| <b>No</b> | Ramp Cross Slope LT (%) | <b>2.7</b> | <b>No</b> | Ramp Cross Slope RT (%) | <b>2.2</b> |

**Remove & Replace Curb Ramp With Two New Directional Ramps or Equivalent.**
