# Access Compliance Report Public Rights-of-Way (Curb Ramps)

Main Street: **O\_NEILL\_DR** Cross Street: **NARROW\_CANYON\_RD** Location: **S**

ADA ID: **RPRK211027123520** Ramp Type: **Type 6 - Directional 1** Initial Pass/Fail: **Fail** Overall Compliance: **No** Severity Score: **15**

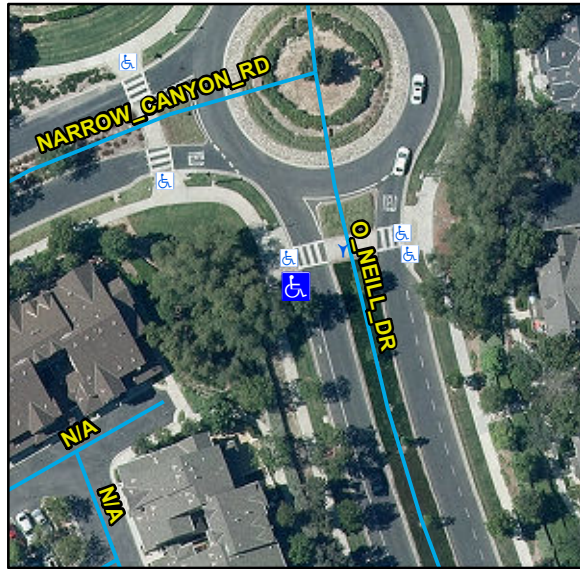
**R204.3, R304.2.2, STD 1115**

| Compliance | Description | Data | Compliance | Description | Data |
|---|---|---|---|---|---|
| <b>No</b> | Ramp Run Slope (%) | <b>10.8</b> | <b>N/A</b> | Flare Slope LT (%) | <b>N/A</b> |

**Remove & Replace Entire Ramp.**
