# Access Compliance Report Public Rights-of-Way (Curb Ramps)

Main Street: O\_NEILL\_DR Cross Street: NARROW\_CANYON\_RD Location: S

ADA ID: RPRK211027123651 Ramp Type: Type 6 - Directional 1 Initial Pass/Fail: Fail Overall Compliance: No Severity Score: 15

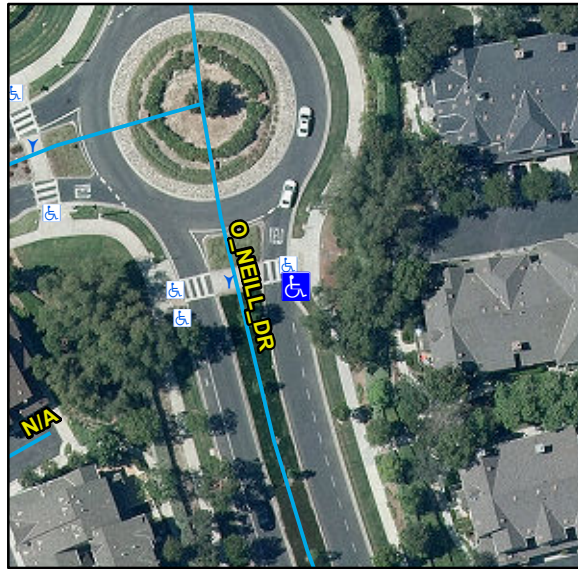
R204.3, R304.2.2, STD 1115

| Compliance | Description | Data | Compliance | Description | Data |
|---|---|---|---|---|---|
| No | Ramp Run Slope (%) | 9.9 | N/A | Flare Slope LT (%) | N/A |

Remove & Replace Entire Ramp.

Total Cost: \$ 3080
