# Access Compliance Report Public Rights-of-Way (Curb Ramps)

Main Street: O\_NEILL\_DR Cross Street: NARROW\_CANYON\_RD Location: N

ADA ID: RPRK211027124205 Ramp Type: Type 6 - Directional 1 Initial Pass/Fail: Fail Overall Compliance: No Severity Score: 15

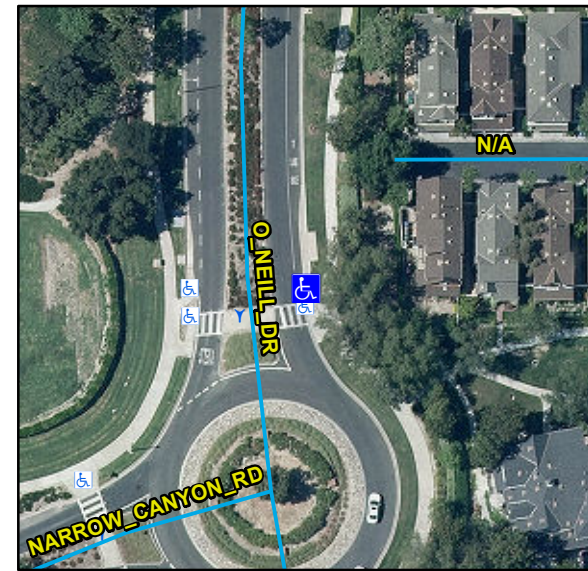
| Compliance | Description | Data | Compliance | Description | Data |
|---|---|---|---|---|---|
| No | Ramp Cross Slope (%) | 5.9 | N/A | Flare Traversable LT | N/A |

Possible Solutions:

Remove & Replace Entire Ramp.

R204.3, R304.5.3, STD 1115

Total Cost: \$ 3080
