Access Compliance Report Public Rights-of-Way (Curb Ramps)

Main Street: NARROW_CANYON_RD **Cross Street:** O_NEILL_DR **Location:** W

ADA ID: RPRK211027124744 **Ramp Type:** Type 1 - Perpendicular **Initial Pass/Fail:** Fail **Overall Compliance:** No **Severity Score:** 15

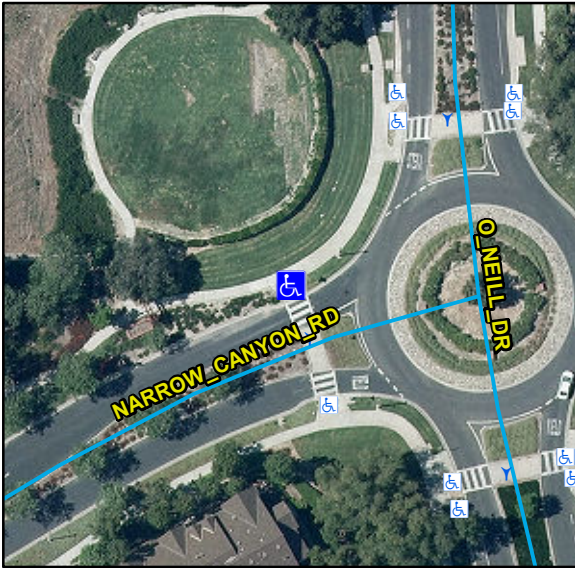
Compliance	Description	Data	Compliance	Description	Data
N/A	Ramp Length (in)	108	N/A	Flare Type LT	
Yes	Ramp Width (in)	48			N/A
No	Ramp Run Slope (%)	10.6	N/A	Flare Slope LT (%)	N/A
Yes	Ramp Cross Slope (%)	0.6	N/A	Flare Traversable LT	N/A
N/A	Landing Present	N/A	N/A	Flare Type RT	
N/A	Landing Length (in)	N/A			N/A
N/A	Landing Width (in)	N/A	N/A	Flare Slope RT (%)	N/A
N/A	Landing Run Slope (%)	N/A	N/A	Flare Traversable RT	N/A
N/A	Landing Cross Slope (%)	N/A	N/A	DWS Provided	N/A
N/A	Landing Movement Obstructed?	N/A	N/A	DWS Contrast	N/A
	Landing Movement Type	N/A	N/A	DWS Length (in)	N/A
N/A	Landing Shared	N/A	N/A	DWS Full Width	N/A
N/A	Clear Space	N/A	N/A	DWS Offset Left (in)	N/A
N/A	Clear Space To Crosswalk (in)	N/A	N/A	DWS Offset Right (in)	N/A
N/A	Marked Crosswalk 1	Yes	N/A	Marked Crosswalk 2	N/A
	Crossing 1 Direction	S		Crossing 2 Direction	N/A
	Marked Crosswalk 1 Width (in)	144		Marked Crosswalk 2 Width (in)	N/A

N/A	Ramp Inside Crosswalk 1	Yes	Yes	Ramp Inside Crosswalk 2	N/A
	Crossing 1 Slope (%)	1.6		Crossing 2 Slope (%)	N/A
	Crossing 1 Cross Slope (%)	2.5		Crossing 2 Cross Slope (%)	N/A
N/A	Gutter Ponding	N/A	No	Curb Slope	8.3
Yes	Gutter Lip Height (in)	0		Road Run Slope (%)	N/A
N/A	Gutter Run Slope (%)	N/A		Road Cross Slope (%)	N/A
N/A	Gutter Cross Slope (%)	N/A			
Yes	Overall Surface Condition: Acceptable		No	Perp Joint Present	No
	Cross Gutter Present?	No		Spandrel Present?	No
	Replace Cross Gutter?	N/A		Replace Spandrel?	N/A

Possible Solutions:
Remove & Replace Entire Ramp.
