# Access Compliance Report Public Rights-of-Way (Curb Ramps)

Main Street: **NARROW\_CANYON\_RD** Cross Street: **O\_NEILL\_DR** Location: **W**

ADA ID: **RPRK211027124936** Ramp Type: **Type 1 - Perpendicular** Initial Pass/Fail: **Fail** Overall Compliance: **No** Severity Score: **2**

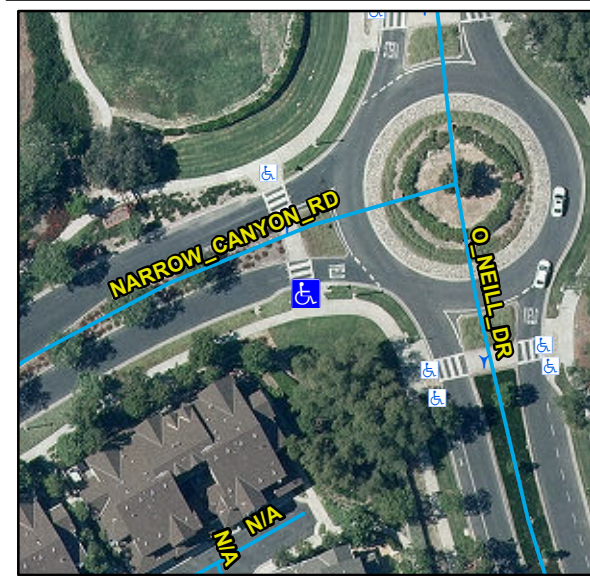
OC Std/PROW:  
**R304.2.2, R204.3, R304.5.3, STD 1115**

| Compliance | Description | Data | Compliance | Description | Data |
|---|---|---|---|---|---|
| No | Ramp Cross Slope (%) | 3 | N/A | Flare Traversable LT | N/A |
| N/A | Gutter Ponding | N/A | No | Curb Slope | 12.4 |

Possible Solutions:  
**Remove & Replace Entire Ramp.**

Total Cost: \$ **3080**
