# Access Compliance Report Public Rights-of-Way (Curb Ramps)

Main Street: MELODY\_LN Cross Street: LULLABY\_CIR Location: N

ADA ID: RPRK211027131710 Ramp Type: Type 4 - Parallel Initial Pass/Fail: Pass Overall Compliance: No Severity Score: 25

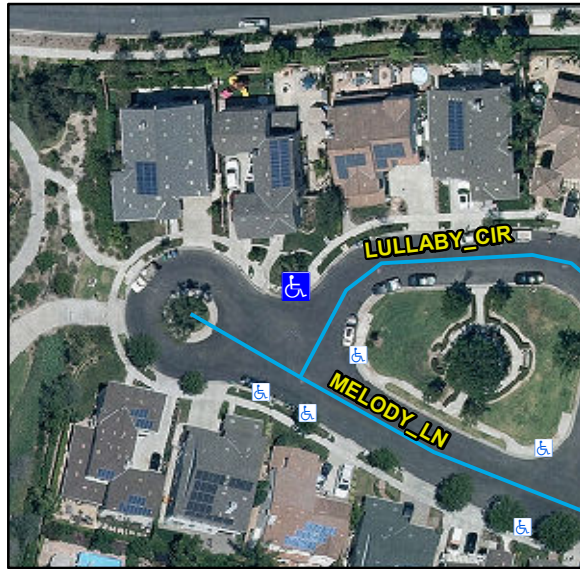
| Compliance | Description | Data | Compliance | Description | Data |
|---|---|---|---|---|---|
| N/A | Landing Present | No | No | DWS Provided | No |
| No | Landing Width (in) | N/A | N/A | DWS Length (in) | N/A |
| No | Gutter Ponding | Yes | No | Curb Slope | 10 |
| No | Gutter Run Slope (%) | 7.6 | | Road Cross Slope (%) | 7.9 |

Remove & Replace Curb Ramp With Two New Directional Ramps or Equivalent. Remove & Replace Gutter.
