# Access Compliance Report Public Rights-of-Way (Curb Ramps)

Main Street: LULLABY\_CIR Cross Street: MELODY\_LN Location: E

ADA ID: RPRK211027132053 Ramp Type: Type 4 - Parallel Initial Pass/Fail: Fail Overall Compliance: No Severity Score: 2

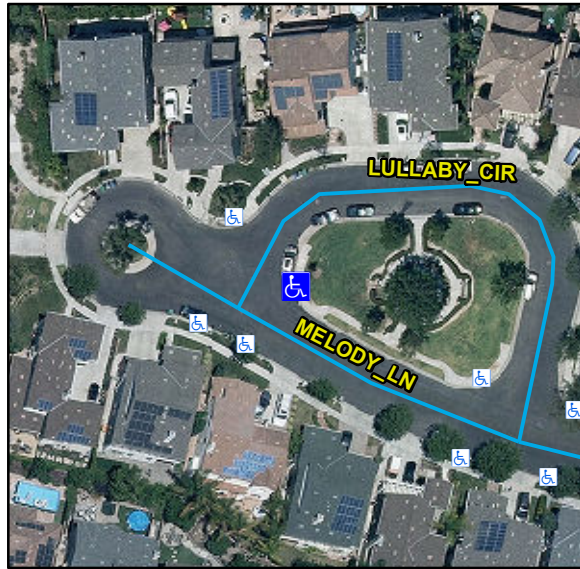
| Compliance | Description | Data | Compliance | Description | Data |
|---|---|---|---|---|---|
| Yes | Ramp Cross Slope LT (%) | 1.4 | No | Ramp Cross Slope RT (%) | 2.8 |

Remove & Replace Curb Ramp With Two New Directional Ramps or Equivalent.

R204.3, R304.5.3, STD 1115
