# Access Compliance Report Public Rights-of-Way (Curb Ramps)

Main Street: MELODY\_LN Cross Street: LULLABY\_CIR Location: N

ADA ID: RPRK211027132357 Ramp Type: Type 4 - Parallel Initial Pass/Fail: Fail Overall Compliance: No Severity Score: 2

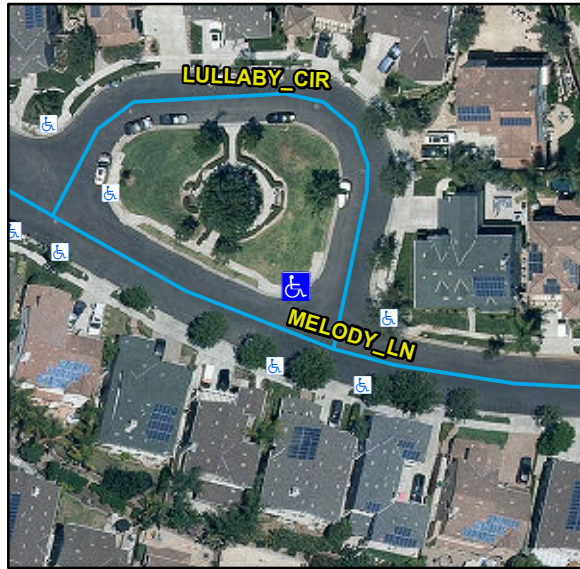
| Compliance | Description | Data | Compliance | Description | Data |
|---|---|---|---|---|---|
| No | Ramp Cross Slope LT (%) | 2.8 | No | Ramp Cross Slope RT (%) | 2.8 |

**Remove & Replace Curb Ramp With Two New Directional Ramps or Equivalent.**

**R204.3, R304.5.3, STD 1115**
