Access Compliance Report Public Rights-of-Way (Curb Ramps)

Main Street: LULLABY_CIR **Cross Street:** MELODY_LN **Location:** E

ADA ID: RPRK211027132553 **Ramp Type:** Type 4 - Parallel **Initial Pass/Fail:** Fail **Overall Compliance:** No **Severity Score:** 16

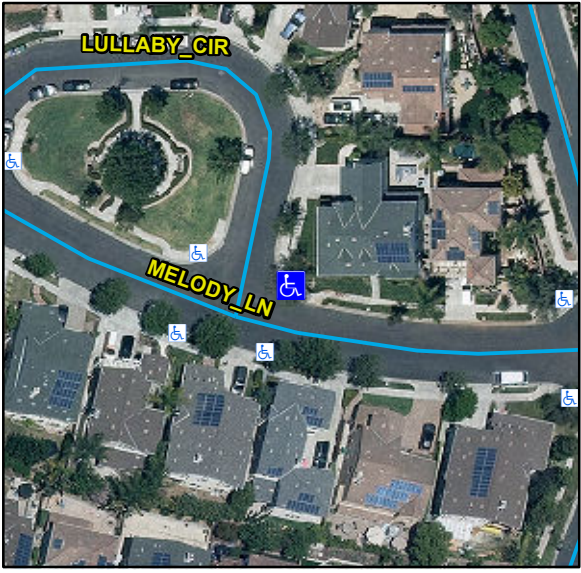
Compliance	Description	Data	Compliance	Description	Data
N/A	Ramp Length LT (in)	109	N/A	Ramp Length RT (in)	106
Yes	Ramp Width LT (in)	53	Yes	Ramp Width RT (in)	53
Yes	Ramp Run Slope LT (%)	0.2	No	Ramp Run Slope RT (%)	8.6
No	Ramp Cross Slope LT (%)	3	No	Ramp Cross Slope RT (%)	2.7
N/A	Landing Present	N/A	N/A	DWS Provided	N/A
N/A	Landing Length (in)	N/A	N/A	DWS Contrast	N/A
N/A	Landing Width (in)	N/A	N/A	DWS Length (in)	N/A
N/A	Landing Run Slope (%)	N/A	N/A	DWS Full Width	N/A
N/A	Landing Cross Slope (%)	N/A		DWS Offset Type	N/A
N/A	Landing Movement Obstructed?	N/A	N/A	DWS Offset Left (in)	N/A
	Landing Movement Type	N/A	N/A	DWS Offset Right (in)	N/A
N/A	Landing Shared	N/A			
N/A	Clear Space	Yes			
N/A	Clear Space To Crosswalk (in)	N/A			
N/A	Marked Crosswalk 1	No	N/A	Marked Crosswalk 2	No
	Crossing 1 Direction	NW		Crossing 2 Direction	SW
N/A	Marked Crosswalk 1 Width (in)	N/A		Marked Crosswalk 2 Width (in)	N/A

N/A	Ramp Inside Crosswalk 1	N/A	N/A	Ramp Inside Crosswalk 2	N/A
	Crossing 1 Slope (%)	3.3		Crossing 2 Slope (%)	1.9
	Crossing 1 Cross Slope (%)	1.6		Crossing 2 Cross Slope (%)	2.6
N/A	Gutter Ponding	N/A	N/A	Curb Slope	6.8
Yes	Gutter Lip Height (in)	0		Road Run Slope (%)	4.3
N/A	Gutter Run Slope (%)	N/A		Road Cross Slope (%)	3.5
N/A	Gutter Cross Slope (%)	N/A	No	Perpendicular Joint Present	No
Yes	Overall Surface Condition	Acceptable			
	Cross Gutter Present?	No		Spandrel Present?	No
	Replace Cross Gutter?	N/A		Replace Spandrel?	N/A

Possible Solutions:
Remove & Replace Curb Ramp With Two New Directional Ramps or Equivalent.

OC Std/PROW:
 R204.3, R304.5.3, R304.3.2, STD 1115

Total Cost: \$ 4000
