# Access Compliance Report Public Rights-of-Way (Curb Ramps)

Main Street: CITRUS\_LN Cross Street: ETHEREAL\_ST Location: N

ADA ID: RPRK211027133306 Ramp Type: Type 4 - Parallel Initial Pass/Fail: Fail Overall Compliance: No Severity Score: 2

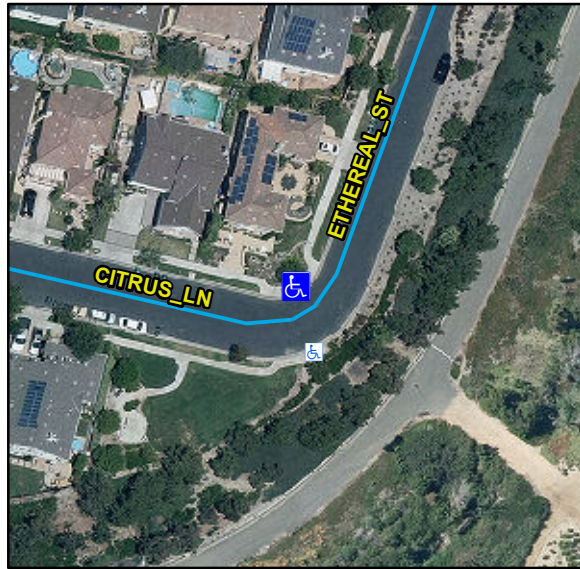
| Compliance | Description | Data | Compliance | Description | Data |
|---|---|---|---|---|---|
| No | Ramp Cross Slope LT (%) | 2.7 | Yes | Ramp Cross Slope RT (%) | 2 |

**Remove & Replace Curb Ramp With Two New Directional Ramps or Equivalent.**
