# Access Compliance Report Public Rights-of-Way (Curb Ramps)

Main Street: ETHEREAL\_ST Cross Street: TANGO\_LN Location: W

ADA ID: RPRK211027133546 Ramp Type: Type 4 - Parallel Initial Pass/Fail: Fail Overall Compliance: No Severity Score: 2

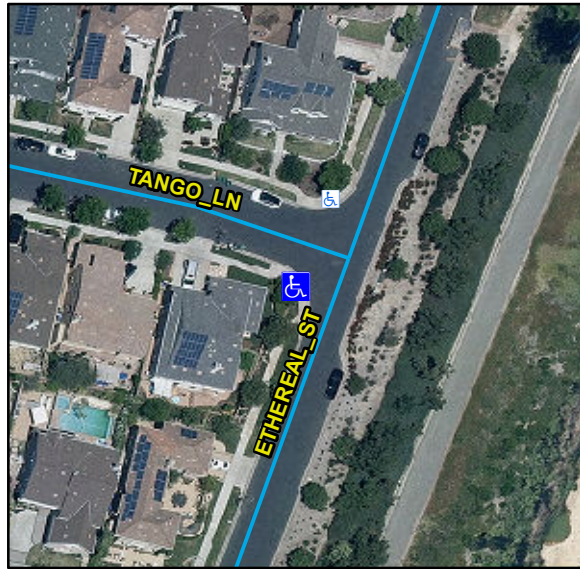
| Compliance | Description | Data | Compliance | Description | Data |
|---|---|---|---|---|---|
| Yes | Ramp Cross Slope LT (%) | 1.7 | No | Ramp Cross Slope RT (%) | 2.9 |
| N/A | Gutter Ponding | N/A | No | Curb Slope | 14.5 |
| N/A | Gutter Cross Slope (%) | N/A | No | Perpendicular Joint Present | No |

**Remove & Replace Curb Ramp With Two New Directional Ramps or Equivalent.**

**R304.2.2, R204.3, R304.5.3, STD 1115**
