# Access Compliance Report Public Rights-of-Way (Curb Ramps)

Main Street: TANGO\_LN Cross Street: ETHEREAL\_ST Location: N

ADA ID: RPRK211027133834 Ramp Type: Type 4 - Parallel Initial Pass/Fail: Fail Overall Compliance: No Severity Score: 2

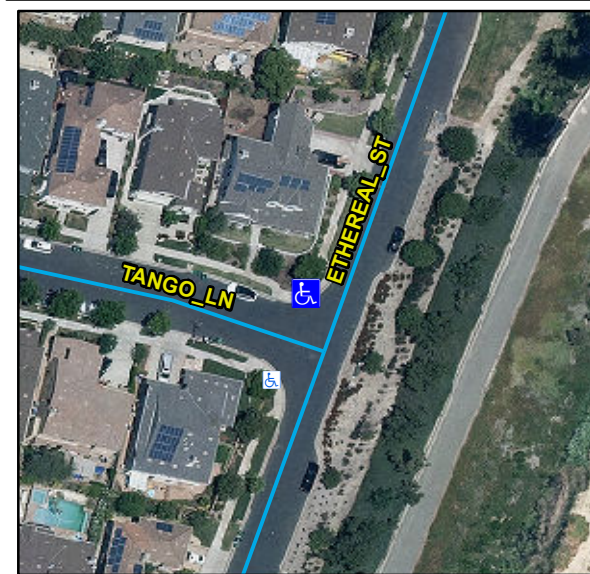
| Compliance | Description | Data | Compliance | Description | Data |
|---|---|---|---|---|---|
| No | Ramp Cross Slope LT (%) | 2.9 | Yes | Ramp Cross Slope RT (%) | 1 |

Remove & Replace Curb Ramp With Two New Directional Ramps or Equivalent.

R204.3, R304.5.3, STD 1115

Total Cost: \$ 4000
