# Access Compliance Report Public Rights-of-Way (Curb Ramps)

| Main Street: ETHEREAL_ST | | Cross Street: MELODY_LN | | Location: | SW |
| ADA ID: RPRK211027134103 | Ramp Type: Type 4 - Parallel | Initial Pass/Fail: Fail | Overall Compliance: No | Severity Score: | 2 |

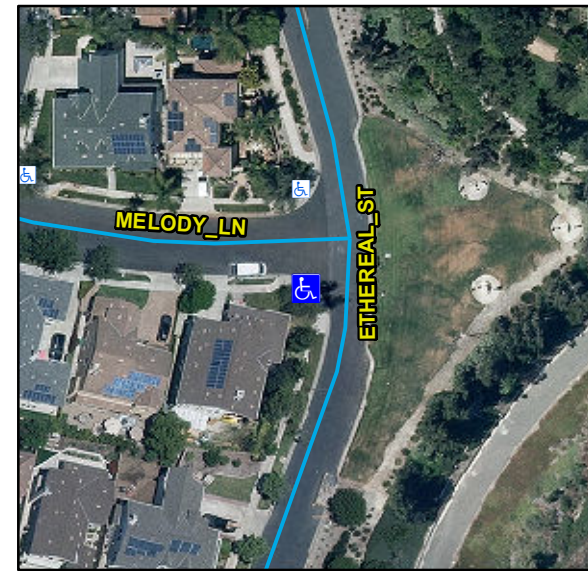
| Compliance | Description | Data | Compliance | Description | Data |
|---|---|---|---|---|---|
| No | Ramp Cross Slope LT (%) | 2.3 | Yes | Ramp Cross Slope RT (%) | 1.6 |

**Remove & Replace Curb Ramp With Two New Directional Ramps or Equivalent.**

**R204.3, R304.5.3, STD 1115**

Total Cost: \$ 4000

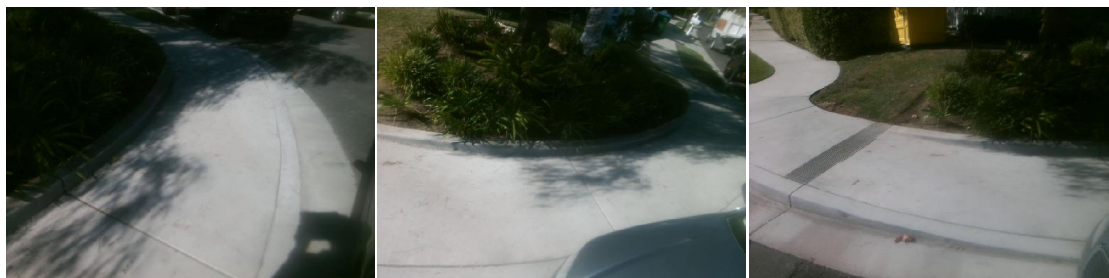
| Compliance | Description | Data | Compliance | Description | Data |
|---|---|---|---|---|---|
| N/A | Ramp Length LT (in) | 120 | N/A | Ramp Length RT (in) | 136 |
| Yes | Ramp Width LT (in) | 53 | Yes | Ramp Width RT (in) | 54 |
| Yes | Ramp Run Slope LT (%) | 3.1 | Yes | Ramp Run Slope RT (%) | 3.7 |
