# Access Compliance Report Public Rights-of-Way (Curb Ramps)

Main Street: MELODY\_LN Cross Street: ETHEREAL\_ST Location: NW

ADA ID: RPRK211027134407 Ramp Type: Type 4 - Parallel Initial Pass/Fail: Fail Overall Compliance: No Severity Score: 16

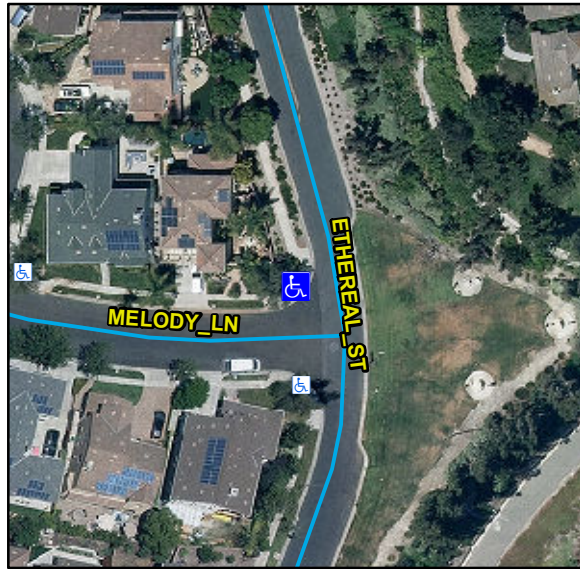
| Compliance | Description | Data | Compliance | Description | Data |
|---|---|---|---|---|---|
| Yes | Ramp Run Slope LT (%) | 0.9 | No | Ramp Run Slope RT (%) | 11.1 |
| No | Ramp Cross Slope LT (%) | 3.5 | No | Ramp Cross Slope RT (%) | 2.8 |

Remove & Replace Curb Ramp With Two New Directional Ramps or Equivalent.

R204.3, R304.5.3, R304.3.2, STD 1115
