# Access Compliance Report Public Rights-of-Way (Curb Ramps)

Main Street: ETHEREAL\_ST Cross Street: NARROW\_CANYON\_RD Location: S

ADA ID: RPRK211027134651 Ramp Type: Type 1 - Perpendicular Initial Pass/Fail: Fail Overall Compliance: No Severity Score: 16

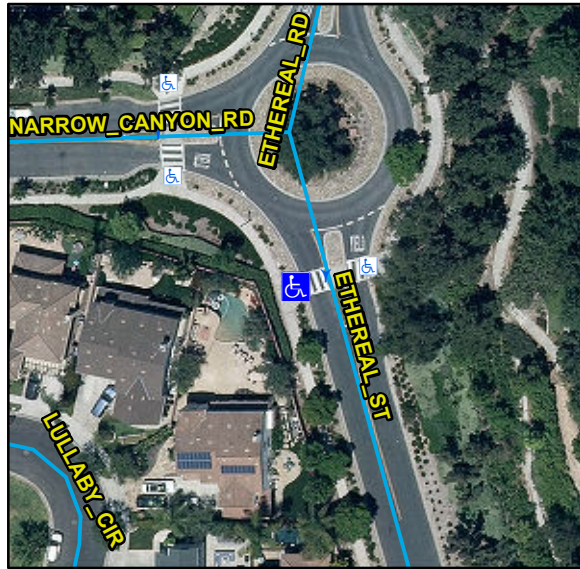
| Compliance | Description | Data | Compliance | Description | Data |
|---|---|---|---|---|---|
| No | Ramp Run Slope (%) | 11.3 | N/A | Flare Slope LT (%) | N/A |
| N/A | Gutter Ponding | N/A | No | Curb Slope | 10.2 |

Remove & Replace Entire Ramp.

R304.2.2, R204.3, STD 1115

Total Cost: \$ 3080
