# Access Compliance Report Public Rights-of-Way (Curb Ramps)

Main Street: ETHEREAL\_ST Cross Street: NARROW\_CANYON\_RD Location: S

ADA ID: RPRK211027134828 Ramp Type: Type 1 - Perpendicular Initial Pass/Fail: Fail Overall Compliance: No Severity Score: 15

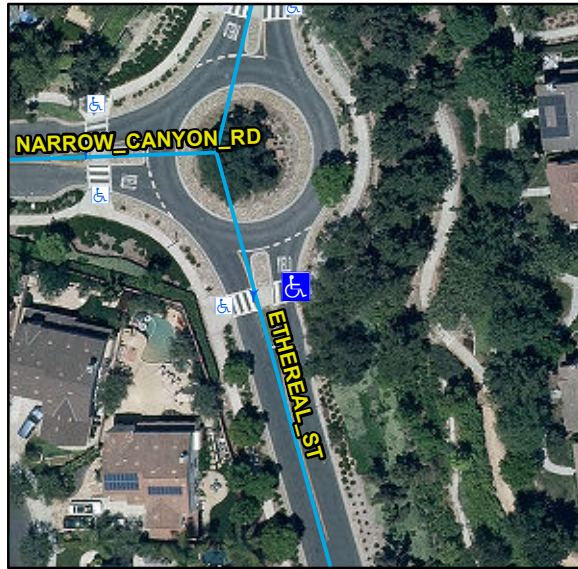
| Compliance | Description | Data | Compliance | Description | Data |
|---|---|---|---|---|---|
| No | Ramp Run Slope (%) | 10.3 | N/A | Flare Slope LT (%) | N/A |
| N/A | Gutter Ponding | N/A | No | Curb Slope | 10.8 |

Remove & Replace Entire Ramp.

R304.2.2, R204.3, STD 1115

Total Cost: \$ 3080
