# Access Compliance Report Public Rights-of-Way (Curb Ramps)

Main Street: ETHEREAL\_RD Cross Street: NARROW\_CANYON\_RD Location: N

ADA ID: RPRK211027134942 Ramp Type: Type 1 - Perpendicular Initial Pass/Fail: Fail Overall Compliance: No Severity Score: 15

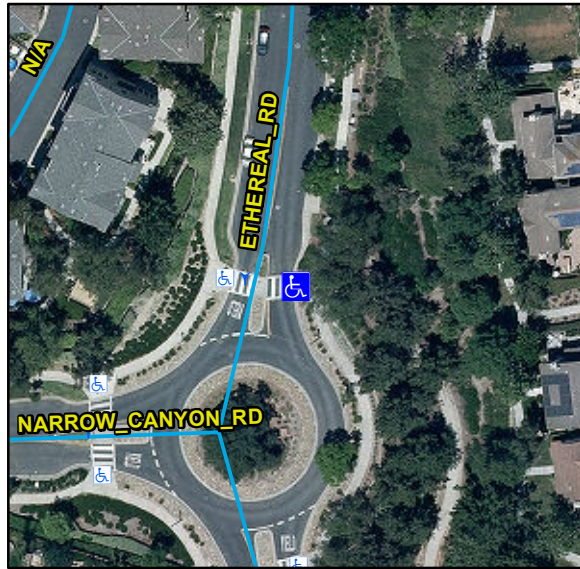
| Compliance | Description | Data | Compliance | Description | Data |
|---|---|---|---|---|---|
| No | Ramp Run Slope (%) | 10.9 | N/A | Flare Slope LT (%) | N/A |

Possible Solutions:

Remove & Replace Entire Ramp.

R304.2.2, R204.3, STD 1115
