# Access Compliance Report Public Rights-of-Way (Curb Ramps)

Main Street: ETHEREAL\_RD Cross Street: NARROW\_CANYON\_RD Location: N

ADA ID: RPRK211027135131 Ramp Type: Type 1 - Perpendicular Initial Pass/Fail: Fail Overall Compliance: No Severity Score: 16

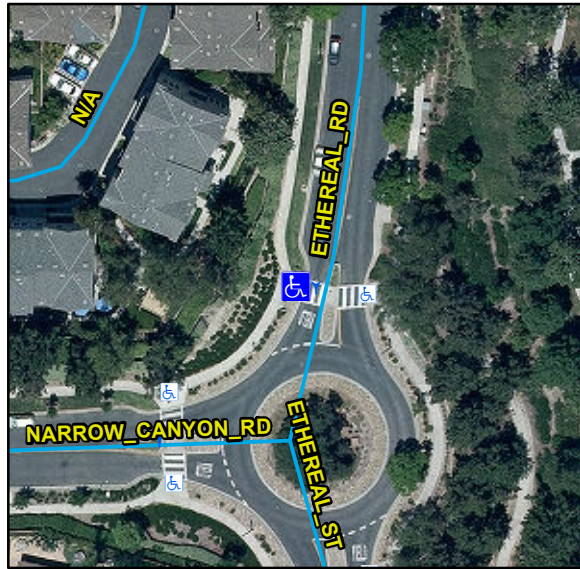
| Compliance | Description | Data | Compliance | Description | Data |
|---|---|---|---|---|---|
| No | Ramp Run Slope (%) | 11.2 | N/A | Flare Slope LT (%) | N/A |
| No | Ramp Cross Slope (%) | 4 | N/A | Flare Traversable LT | N/A |

Remove & Replace Entire Ramp.

R304.2.2, R204.3, R304.5.3, STD 1115
