# Access Compliance Report Public Rights-of-Way (Curb Ramps)

Main Street: NARROW\_CANYON\_RD Cross Street: ETHEREAL\_RD Location: W

ADA ID: RPRK211027135236 Ramp Type: Type 1 - Perpendicular Initial Pass/Fail: Fail Overall Compliance: No Severity Score: 15

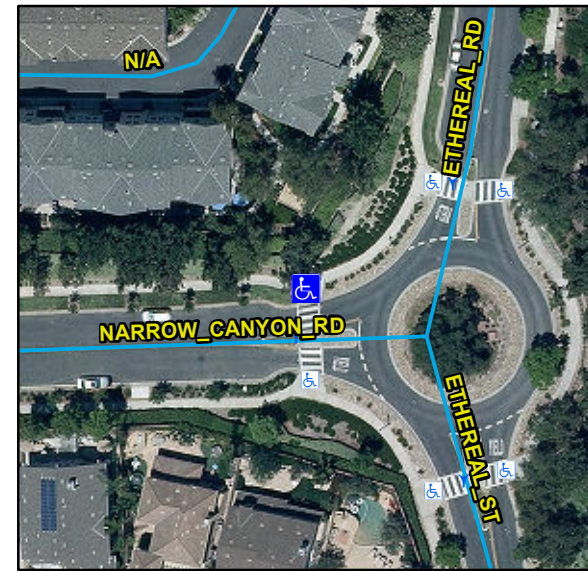
| Compliance | Description | Data | Compliance | Description | Data |
|---|---|---|---|---|---|
| No | Ramp Run Slope (%) | 9.5 | N/A | Flare Slope LT (%) | N/A |

Remove & Replace Entire Ramp.
