# Access Compliance Report Public Rights-of-Way (Curb Ramps)

| Main Street: ETHEREAL_ST | | Cross Street: NARROW_CANYON_RD | | Location: | W |
| ADA ID: RPRK211027135416 | Ramp Type:Type 1 - Perpendicular | Initial Pass/Fail: Pass | Overall Compliance: No | Severity Score: | 17 |

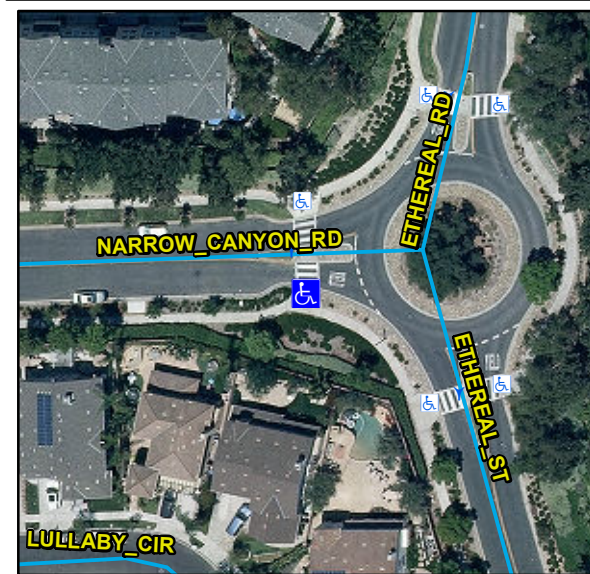
| Compliance | Description | Data | Compliance | Description | Data |
|---|---|---|---|---|---|
| No | Landing Run Slope (%) | 3.5 | N/A | Flare Traversable RT | No |
| No | Landing Cross Slope (%) | 2.1 | No | DWS Provided | No |
| No | Gutter Run Slope (%) | 8.7 | | Road Cross Slope (%) | N/A |

**Remove & Replace Entire Ramp. Remove & Replace Gutter.**
