# Access Compliance Report Public Rights-of-Way (Curb Ramps)

Main Street: ILLUMINATA\_LN Cross Street: EPONA\_WAY Location: S

ADA ID: RPRK211027141331 Ramp Type: Type 4 - Parallel Initial Pass/Fail: Pass Overall Compliance: No Severity Score: 25

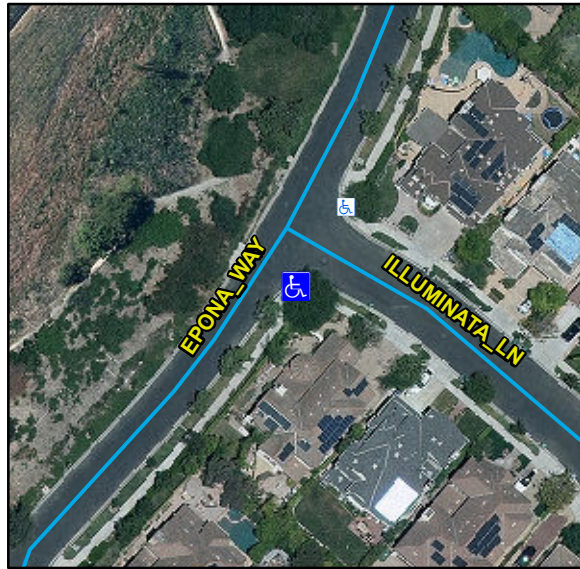
| Compliance | Description | Data | Compliance | Description | Data |
|---|---|---|---|---|---|
| N/A | Landing Present | No | No | DWS Provided | No |
| No | Landing Width (in) | N/A | N/A | DWS Length (in) | N/A |
| No | Landing Run Slope (%) | N/A | N/A | DWS Full Width | N/A |
| No | Landing Cross Slope (%) | N/A | | DWS Offset Type | N/A |
| No | Gutter Run Slope (%) | 5.5 | | Road Cross Slope (%) | 2.4 |
| No | Gutter Cross Slope (%) | 3 | No | Perpendicular Joint Present | No |

Remove & Replace Curb Ramp With Two New Directional Ramps or Equivalent. Remove & Replace Gutter.

R204.3, R304.2.1, R304.2.2-Perp, R304.3.2-Para, R304.5.3, R305, R304.5.4, STD 1115
