# Access Compliance Report Public Rights-of-Way (Curb Ramps)

Main Street: EPONA\_WAY Cross Street: ILLUMINATA\_LN Location: E

ADA ID: RPRK211027141622 Ramp Type: Type 4 - Parallel Initial Pass/Fail: Pass Overall Compliance: No Severity Score: 20

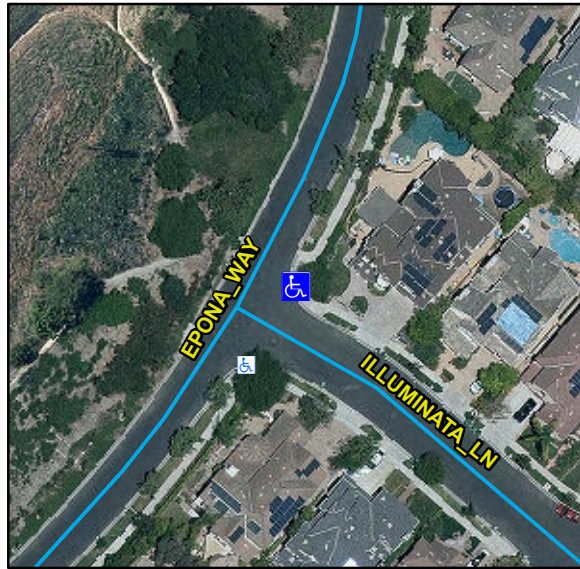
| Compliance | Description | Data | Compliance | Description | Data |
|---|---|---|---|---|---|
| N/A | Landing Present | No | No | DWS Provided | No |
| No | Landing Width (in) | N/A | N/A | DWS Length (in) | N/A |
| No | Landing Run Slope (%) | N/A | N/A | DWS Full Width | N/A |
| No | Landing Cross Slope (%) | N/A | | DWS Offset Type | N/A |

**Remove & Replace Curb Ramp With Two New Directional Ramps or Equivalent.**

**R204.3, R304.2.1, R304.2.2-Perp, R304.3.2-Para, R304.5.3, R305, STD 1115**

Total Cost: \$ 4000
