# Access Compliance Report Public Rights-of-Way (Curb Ramps)

| Main Street: EPONA_WAY | | Cross Street: GALORA_LN | | Location: | E |
| ADA ID: RPRK211027142207 | Ramp Type: Type 4 - Parallel | Initial Pass/Fail: Fail | Overall Compliance: No | Severity Score: | 15 |

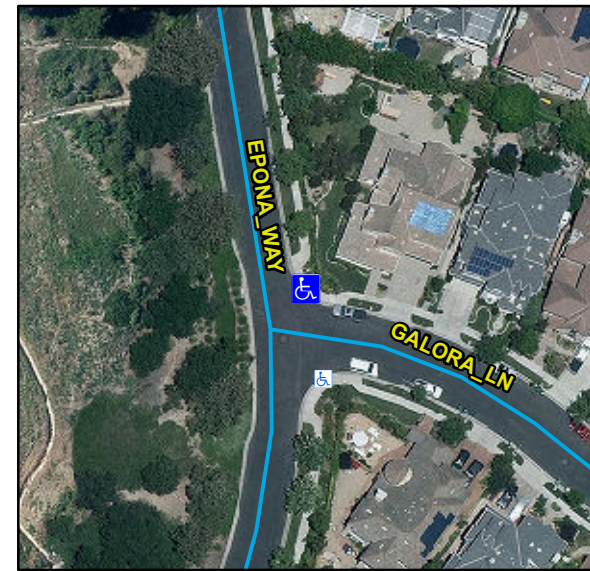
N/A

| Compliance | Description | Data | Compliance | Description | Data |
|---|---|---|---|---|---|
| No | Ramp Run Slope LT (%) | 10.8 | Yes | Ramp Run Slope RT (%) | 1.3 |
| N/A | Gutter Ponding | N/A | N/A | Curb Slope | 13.5 |

**Remove & Replace Curb Ramp With Two New Directional Ramps or Equivalent.**

**R204.3, R304.3.2, STD 1115**

Total Cost: \$ 4000
