# Access Compliance Report Public Rights-of-Way (Curb Ramps)

| Main Street: COPIOUS_LN | | Cross Street: EPONA_WAY | | Location: | S |
| ADA ID: RPRK211027142439 | Ramp Type: Type 4 - Parallel | Initial Pass/Fail: Pass | Overall Compliance: No | Severity Score: | 25 |

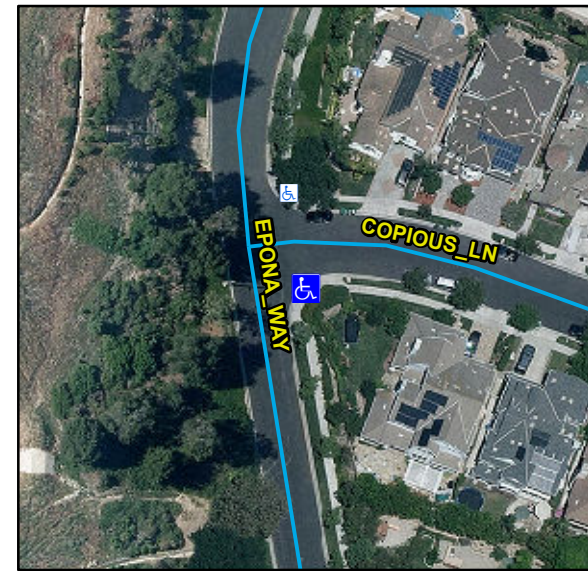
| Compliance | Description | Data | Compliance | Description | Data |
|---|---|---|---|---|---|
| N/A | Landing Present | No | No | DWS Provided | No |
| No | Landing Width (in) | N/A | N/A | DWS Length (in) | N/A |
| No | Landing Run Slope (%) | N/A | N/A | DWS Full Width | N/A |
| No | Landing Cross Slope (%) | N/A | | DWS Offset Type | N/A |
| No | Gutter Run Slope (%) | 6.3 | | Road Cross Slope (%) | 5.2 |

Possible Solutions:

**Remove & Replace Curb Ramp With Two New Directional Ramps or Equivalent. Remove & Replace Gutter.**

**R204.3, R304.2.1, R304.2.2-Perp, R304.3.2-Para, R304.5.3, R305, R304.5.4, STD 1115**

Total Cost: \$ 4252
