# Access Compliance Report Public Rights-of-Way (Curb Ramps)

Main Street: EPONA\_WAY Cross Street: COPIOUS\_LN Location: E

ADA ID: RPRK211027142801 Ramp Type: Type 4 - Parallel Initial Pass/Fail: Pass Overall Compliance: No Severity Score: 20

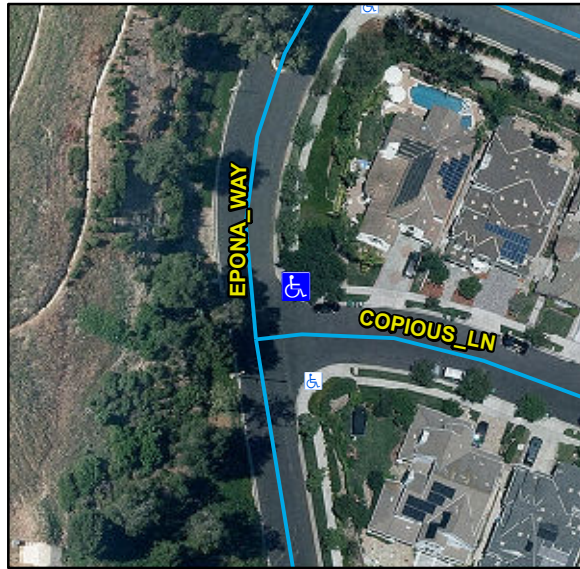
R304.2.2, R204.3, R304.2.1, R304.2.2-Perp, R304.3.2-Para, R304.5.3, R305, STD 1115

Remove & Replace Curb Ramp With Two New Directional Ramps or Equivalent. Remove & Replace Gutter.
