# Access Compliance Report Public Rights-of-Way (Curb Ramps)

| Main Street: NARROW_CANYON_RD | | Cross Street: EPONA_WAY | | Location: | E |
| ADA ID: RPRK211027143152 | Ramp Type:Type 1 - Perpendicular | Initial Pass/Fail: Fail | Overall Compliance: No | Severity Score: | 15 |

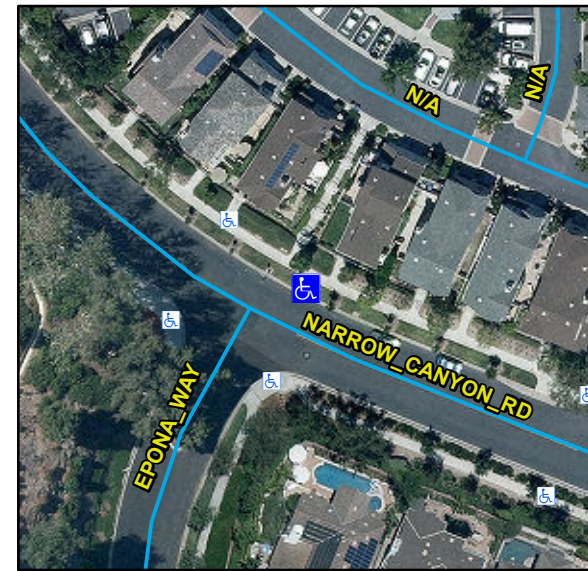
| Compliance | Description | Data | Compliance | Description | Data |
|---|---|---|---|---|---|
| No | Ramp Run Slope (%) | 9.8 | N/A | Flare Slope LT (%) | N/A |
| N/A | Gutter Ponding | N/A | No | Curb Slope | 9.4 |

Possible Solutions:

Remove & Replace Entire Ramp.

R304.2.2, R204.3, STD 1115

Total Cost: \$ 3080
