# Access Compliance Report Public Rights-of-Way (Curb Ramps)

| Main Street: NARROW_CANYON_RD | | Cross Street: EPONA_WAY | | Location: | S |
| ADA ID: RPRK211027143251 | Ramp Type: Type 4 - Parallel | Initial Pass/Fail: Fail | Overall Compliance: No | Severity Score: | 16 |

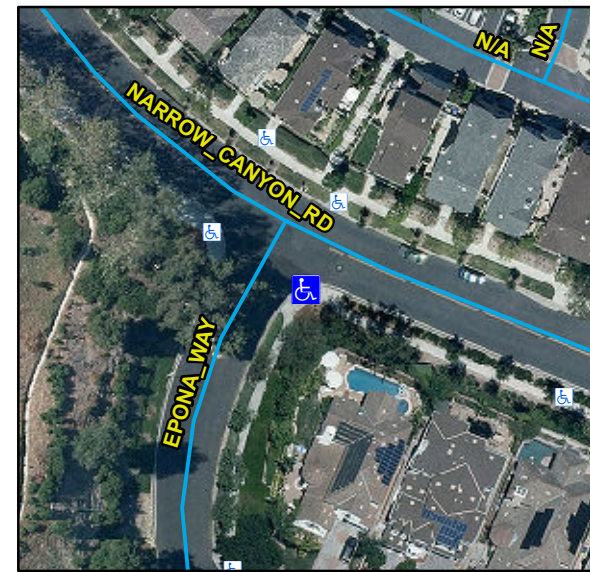
| Compliance | Description | Data | Compliance | Description | Data |
|---|---|---|---|---|---|
| Yes | Ramp Run Slope LT (%) | 1.9 | No | Ramp Run Slope RT (%) | 9.7 |
| No | Ramp Cross Slope LT (%) | 2.8 | Yes | Ramp Cross Slope RT (%) | 0.4 |

**Remove & Replace Curb Ramp With Two New Directional Ramps or Equivalent.**

**R204.3, R304.5.3, R304.3.2, STD 1115**

Total Cost: \$ 4000

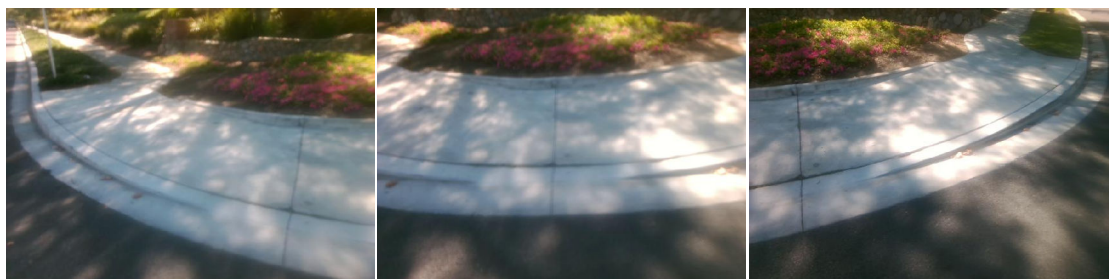
| Compliance | Description | Data | Compliance | Description | Data |
|---|---|---|---|---|---|
| N/A | Ramp Length LT (in) | 134 | N/A | Ramp Length RT (in) | 134 |
| Yes | Ramp Width LT (in) | 89 | Yes | Ramp Width RT (in) | 88 |
