# Access Compliance Report Public Rights-of-Way (Curb Ramps)

Main Street: EPONA\_WAY Cross Street: NARROW\_CANYON\_RD Location: W

ADA ID: RPRK211027143505 Ramp Type: Type 4 - Parallel Initial Pass/Fail: Pass Overall Compliance: No Severity Score: 25

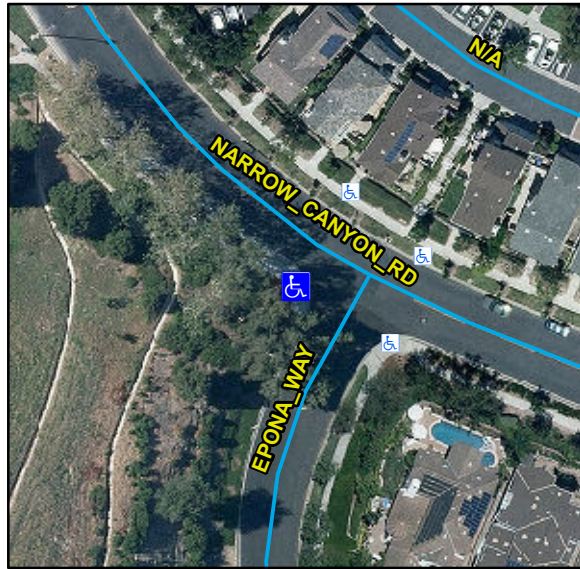
| Compliance | Description | Data | Compliance | Description | Data |
|---|---|---|---|---|---|
| N/A | Landing Present | No | No | DWS Provided | No |
| Yes | Gutter Ponding | No | No | Curb Slope | 12.1 |
| No | Gutter Run Slope (%) | 10.3 | | Road Cross Slope (%) | 0.1 |

Remove & Replace Curb Ramp With Two New Directional Ramps or Equivalent. Remove & Replace Gutter.
