# Access Compliance Report Public Rights-of-Way (Curb Ramps)

| Main Street: <b>MERCANTILE_WAY</b> | | Cross Street: <b>SECOND_ST</b> | | Location: | <b>N</b> |
| ADA ID: <b>RPRK211027170248</b> | Ramp Type: <b>Type 4 - Parallel</b> | Initial Pass/Fail: <b>Fail</b> | Overall Compliance: <b>No</b> | Severity Score: | <b>16</b> |

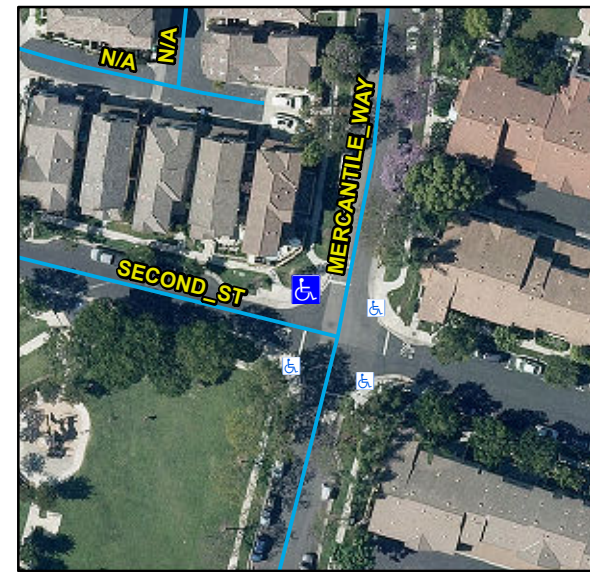
| Compliance | Description | Data | Compliance | Description | Data |
|---|---|---|---|---|---|
| <b>Yes</b> | Ramp Run Slope LT (%) | <b>0.7</b> | <b>No</b> | Ramp Run Slope RT (%) | <b>8.9</b> |
| <b>No</b> | Ramp Cross Slope LT (%) | <b>2.7</b> | <b>No</b> | Ramp Cross Slope RT (%) | <b>2.2</b> |

Possible Solutions:

**Remove & Replace Curb Ramp With Two New Directional Ramps or Equivalent.**

**R204.3, R304.5.3, R304.3.2, STD 1115**
