# Access Compliance Report Public Rights-of-Way (Curb Ramps)

Main Street: **MERCANTILE\_WAY** Cross Street: **SECOND\_ST** Location: **W**

ADA ID: **RPRK211027170804** Ramp Type: **Type 4 - Parallel** Initial Pass/Fail: **Fail** Overall Compliance: **No** Severity Score: **16**

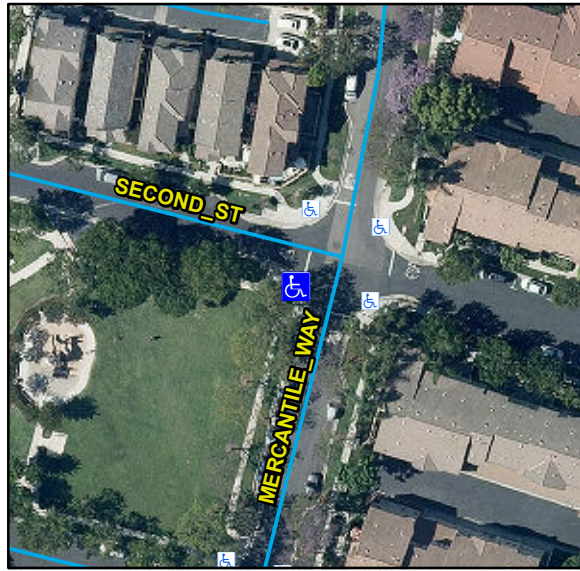
| Compliance | Description | Data | Compliance | Description | Data |
|---|---|---|---|---|---|
| <b>Yes</b> | Ramp Run Slope LT (%) | <b>3.6</b> | <b>No</b> | Ramp Run Slope RT (%) | <b>9.3</b> |
| <b>No</b> | Ramp Cross Slope LT (%) | <b>2.4</b> | <b>Yes</b> | Ramp Cross Slope RT (%) | <b>1</b> |

**Remove & Replace Curb Ramp With Two New Directional Ramps or Equivalent.**
