# Access Compliance Report Public Rights-of-Way (Curb Ramps)

Main Street: THIRD\_RD Cross Street: MERCANTILE\_WAY Location: N

ADA ID: RPRK211027171442 Ramp Type: Type 4 - Parallel Initial Pass/Fail: Fail Overall Compliance: No Severity Score: 15

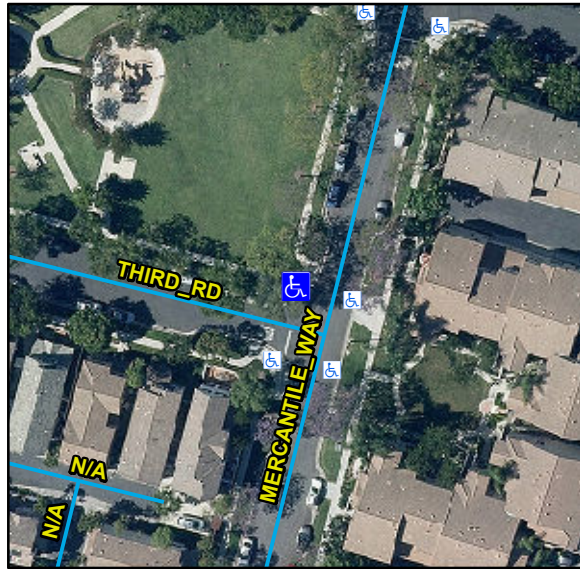
| Compliance | Description | Data | Compliance | Description | Data |
|---|---|---|---|---|---|
| Yes | Ramp Run Slope LT (%) | 6.9 | No | Ramp Run Slope RT (%) | 10.4 |

**Remove & Replace Curb Ramp With Two New Directional Ramps or Equivalent.**

**R204.3, R304.3.2, STD 1115**
