# Access Compliance Report Public Rights-of-Way (Curb Ramps)

Main Street: **MERCANTILE\_WAY** Cross Street: **THIRD\_RD** Location: **W**

ADA ID: **RPRK211027171940** Ramp Type: **Type 4 - Parallel** Initial Pass/Fail: **Fail** Overall Compliance: **No** Severity Score: **2**

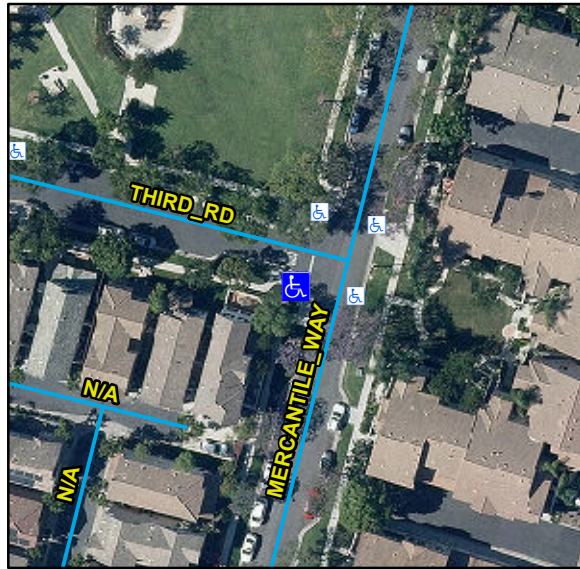
| Compliance | Description | Data | Compliance | Description | Data |
|---|---|---|---|---|---|
| <b>No</b> | Ramp Cross Slope LT (%) | <b>2.5</b> | <b>Yes</b> | Ramp Cross Slope RT (%) | <b>1.8</b> |

**Remove & Replace Curb Ramp With Two New Directional Ramps or Equivalent.**

**R304.5.3, STD 1115**
