# Access Compliance Report Public Rights-of-Way (Curb Ramps)

Main Street: **MERCANTILE\_WAY** Cross Street: **1ST\_ST** Location: **SW**

ADA ID: **RPRK211027173208** Ramp Type: **Type 4 - Parallel** Initial Pass/Fail: **Fail** Overall Compliance: **No** Severity Score: **16**

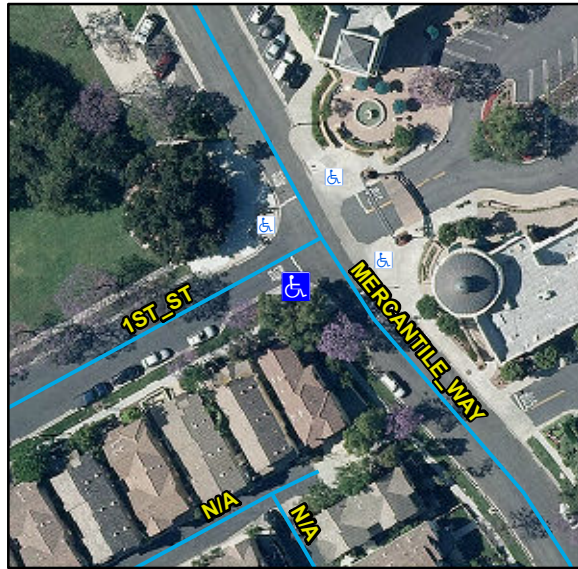
| Compliance | Description | Data | Compliance | Description | Data |
|---|---|---|---|---|---|
| <b>No</b> | Ramp Run Slope LT (%) | <b>9.7</b> | <b>Yes</b> | Ramp Run Slope RT (%) | <b>1.3</b> |
| <b>No</b> | Ramp Cross Slope LT (%) | <b>3.2</b> | <b>Yes</b> | Ramp Cross Slope RT (%) | <b>1.6</b> |

**Remove & Replace Curb Ramp With Two New Directional Ramps or Equivalent.**

**R204.3, R304.3.2, R304.5.3, STD 1115**
