# Access Compliance Report Public Rights-of-Way (Curb Ramps)

Main Street: GAIA\_LN Cross Street: GAIA\_LN Location: S

ADA ID: RPRK211028113753 Ramp Type: Type 4 - Parallel Initial Pass/Fail: Fail Overall Compliance: No Severity Score: 16

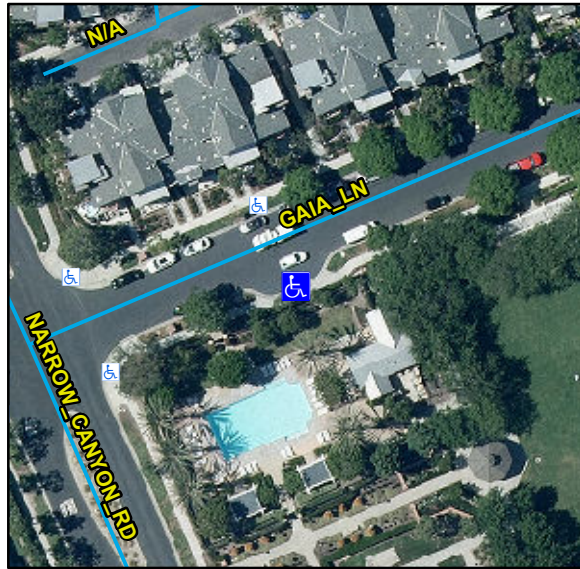
| Compliance | Description | Data | Compliance | Description | Data |
|---|---|---|---|---|---|
| No | Ramp Run Slope LT (%) | 9.8 | Yes | Ramp Run Slope RT (%) | 4.7 |
| No | Ramp Cross Slope LT (%) | 3.2 | Yes | Ramp Cross Slope RT (%) | 1.6 |

Remove & Replace Entire Ramp.

R204.3, R304.3.2, R304.5.3, STD 1115
