# Access Compliance Report Public Rights-of-Way (Curb Ramps)

Main Street: N/A Cross Street: TRIAD\_LN Location: NE

ADA ID: RPRK211028114311 Ramp Type: Type 1 - Perpendicular Initial Pass/Fail: Fail Overall Compliance: No Severity Score: 15

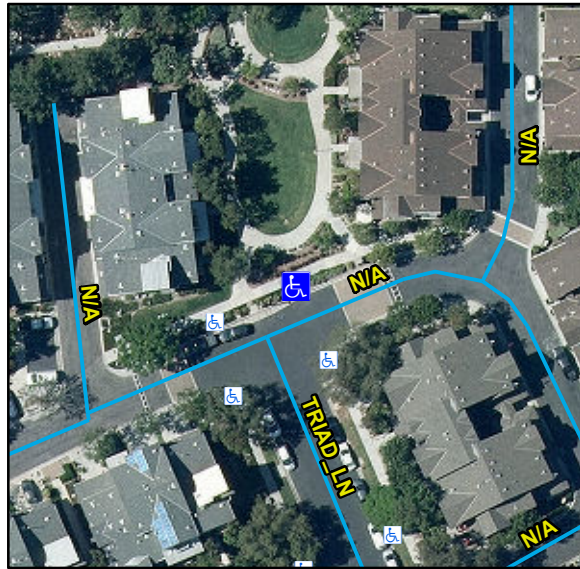
| Compliance | Description | Data | Compliance | Description | Data |
|---|---|---|---|---|---|
| No | Ramp Run Slope (%) | 9.4 | N/A | Flare Slope LT (%) | N/A |

Possible Solutions:

Remove & Replace Entire Ramp.

R304.2.2, R204.3, STD 1115
