# Access Compliance Report Public Rights-of-Way (Curb Ramps)

Main Street: N/A Cross Street: TRIAD\_LN Location: SE

ADA ID: RPRK211028114436 Ramp Type: Type 4 - Parallel Initial Pass/Fail: Fail Overall Compliance: No Severity Score: 2

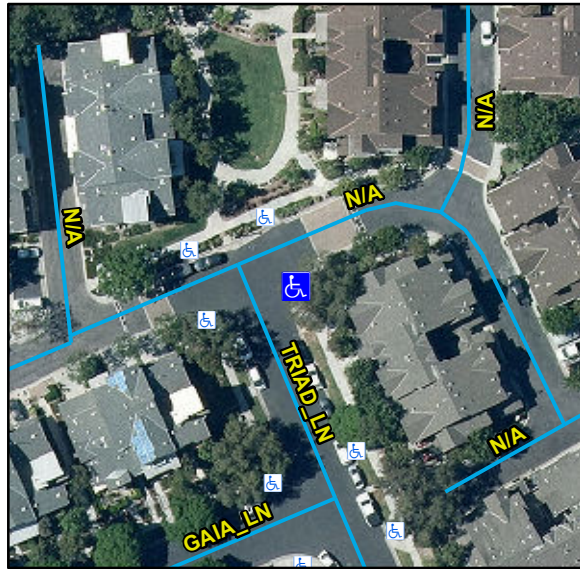
| Compliance | Description | Data | Compliance | Description | Data |
|---|---|---|---|---|---|
| No | Ramp Cross Slope LT (%) | 2.7 | Yes | Ramp Cross Slope RT (%) | 1.9 |

**Remove & Replace Curb Ramp With Two New Directional Ramps or Equivalent.**

**R204.3, R304.5.3, STD 1115**
