# Access Compliance Report Public Rights-of-Way (Curb Ramps)

Main Street: TRIAD\_LN Cross Street: N/A Location: SW

ADA ID: RPRK211028114653 Ramp Type: Type 4 - Parallel Initial Pass/Fail: Fail Overall Compliance: No Severity Score: 2

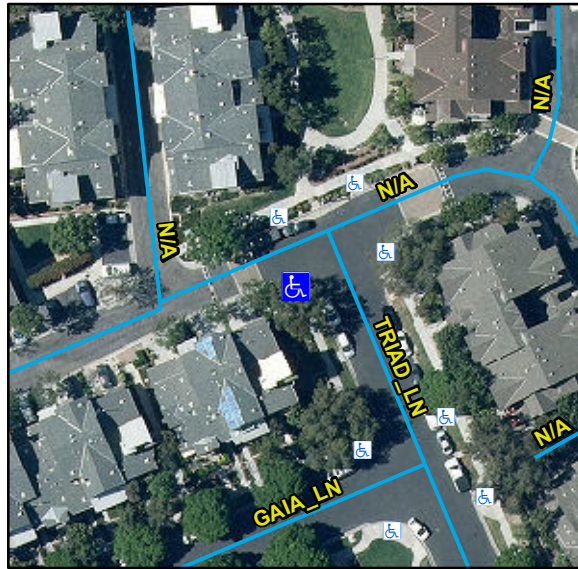
| Compliance | Description | Data | Compliance | Description | Data |
|---|---|---|---|---|---|
| No | Ramp Cross Slope LT (%) | 3 | Yes | Ramp Cross Slope RT (%) | 1.2 |
| N/A | Gutter Ponding | N/A | No | Curb Slope | 8.5 |
| N/A | Gutter Cross Slope (%) | N/A | No | Perpendicular Joint Present | No |

Remove & Replace Curb Ramp With Two New Directional Ramps or Equivalent.

R304.2.2, R204.3, R304.5.3, STD 1115

Total Cost: \$ 4000
