# Access Compliance Report Public Rights-of-Way (Curb Ramps)

Main Street: GAIA\_LN Cross Street: TRIAD\_LN Location: NW

ADA ID: RPRK211028115129 Ramp Type: Type 4 - Parallel Initial Pass/Fail: Fail Overall Compliance: No Severity Score: 16

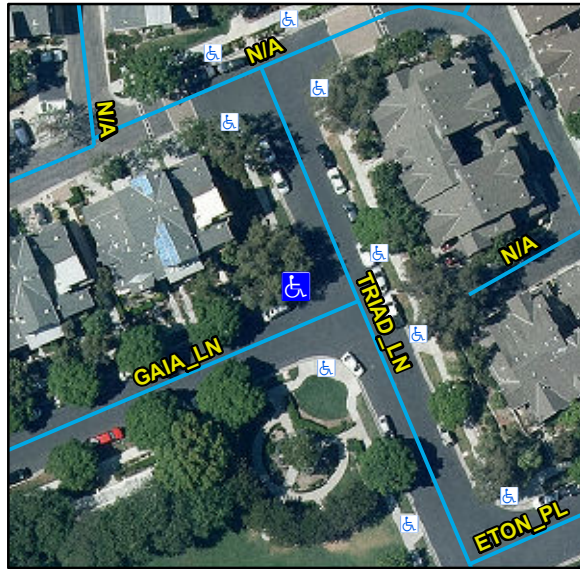
| Compliance | Description | Data | Compliance | Description | Data |
|---|---|---|---|---|---|
| Yes | Ramp Run Slope LT (%) | 1.3 | No | Ramp Run Slope RT (%) | 8.9 |
| No | Ramp Cross Slope LT (%) | 2.5 | Yes | Ramp Cross Slope RT (%) | 1.9 |

Remove & Replace Curb Ramp With Two New Directional Ramps or Equivalent.
