# Access Compliance Report Public Rights-of-Way (Curb Ramps)

Main Street: TRIAD\_LN Cross Street: GAIA\_LN Location: SE

ADA ID: RPRK211028115411 Ramp Type: Type 1 - Perpendicular Initial Pass/Fail: Pass Overall Compliance: No Severity Score: 15

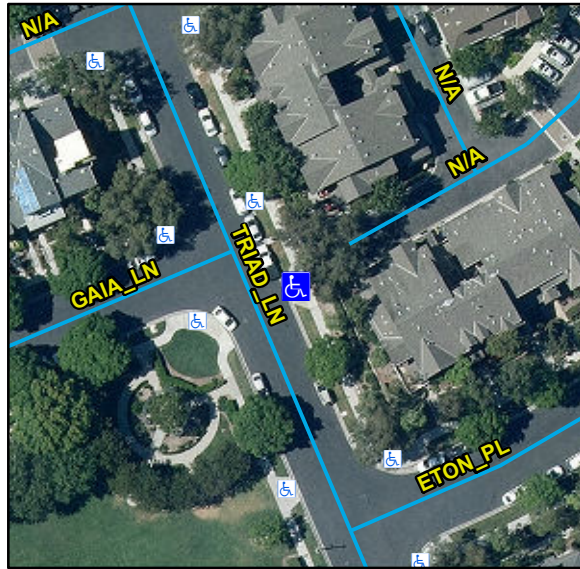
| Compliance | Description | Data | Compliance | Description | Data |
|---|---|---|---|---|---|
| Yes | Landing Cross Slope (%) | 1.7 | No | DWS Provided | No |
| Yes | Gutter Ponding | No | No | Curb Slope | 9 |
| No | Gutter Run Slope (%) | 7 | | Road Cross Slope (%) | N/A |

Remove & Replace Entire Ramp. Remove & Replace Gutter.

R304.2.2, R204.3, R305, R304.5.4, STD 1115
