# Access Compliance Report Public Rights-of-Way (Curb Ramps)

Main Street: TRIAD\_LN Cross Street: GAIA\_LN Location: SW

ADA ID: RPRK211028115636 Ramp Type: Type 4 - Parallel Initial Pass/Fail: Pass Overall Compliance: No Severity Score: 25

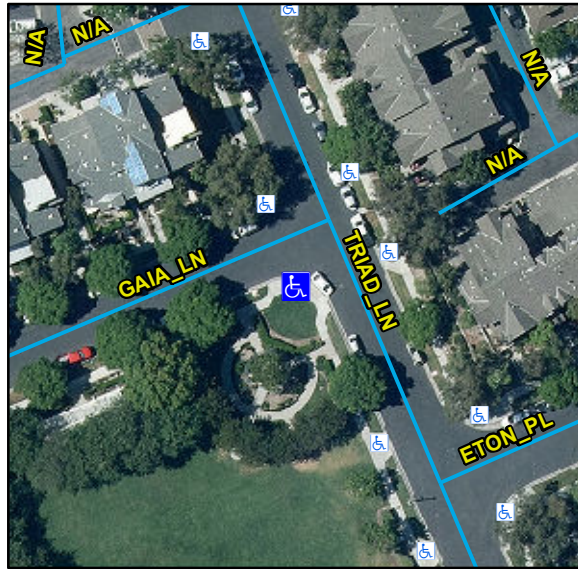
| Compliance | Description | Data | Compliance | Description | Data |
|---|---|---|---|---|---|
| N/A | Landing Present | No | No | DWS Provided | No |
| No | Landing Width (in) | N/A | N/A | DWS Length (in) | N/A |
| No | Landing Run Slope (%) | N/A | N/A | DWS Full Width | N/A |
| No | Landing Cross Slope (%) | N/A | | DWS Offset Type | N/A |
| Yes | Gutter Ponding | No | No | Curb Slope | 9.4 |
| No | Gutter Run Slope (%) | 6.2 | | Road Cross Slope (%) | 3.6 |

Remove & Replace Curb Ramp With Two New Directional Ramps or Equivalent. Remove & Replace Gutter.
