# Access Compliance Report Public Rights-of-Way (Curb Ramps)

Main Street: ETON\_PL Cross Street: N/A Location: SE

ADA ID: RPRK211028120151 Ramp Type: Type 4 - Parallel Initial Pass/Fail: Pass Overall Compliance: No Severity Score: 25

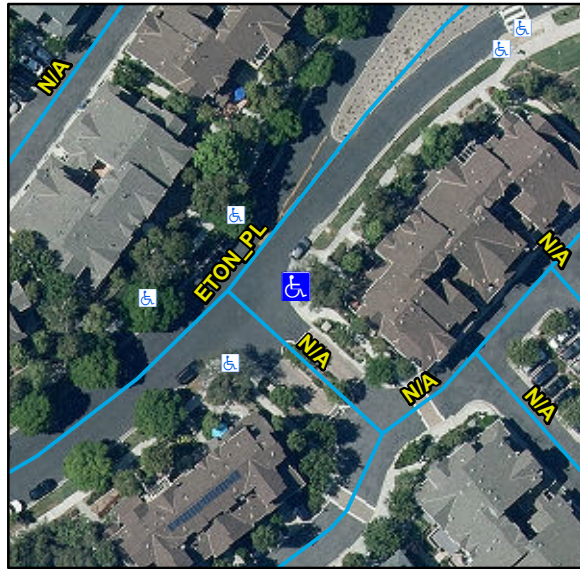
| Compliance | Description | Data | Compliance | Description | Data |
|---|---|---|---|---|---|
| N/A | Landing Present | No | No | DWS Provided | No |
| No | Landing Width (in) | N/A | N/A | DWS Length (in) | N/A |
| No | Landing Run Slope (%) | N/A | N/A | DWS Full Width | N/A |
| No | Landing Cross Slope (%) | N/A | | DWS Offset Type | N/A |
| Yes | Gutter Ponding | No | No | Curb Slope | 10.6 |
| No | Gutter Run Slope (%) | 7.2 | | Road Cross Slope (%) | 1.2 |

Remove & Replace Curb Ramp With Two New Directional Ramps or Equivalent. Remove & Replace Gutter.

R304.2.2, R204.3, R304.2.1, R304.2.2-Perp, R304.3.2-Para, R304.5.3, R305, R304.5.4, STD 1115

Total Cost: \$ 4252
