# Access Compliance Report Public Rights-of-Way (Curb Ramps)

Main Street: N/A Cross Street: ETON\_PL Location: SW

ADA ID: RPRK211028120432 Ramp Type: Type 4 - Parallel Initial Pass/Fail: Pass Overall Compliance: No Severity Score: 26

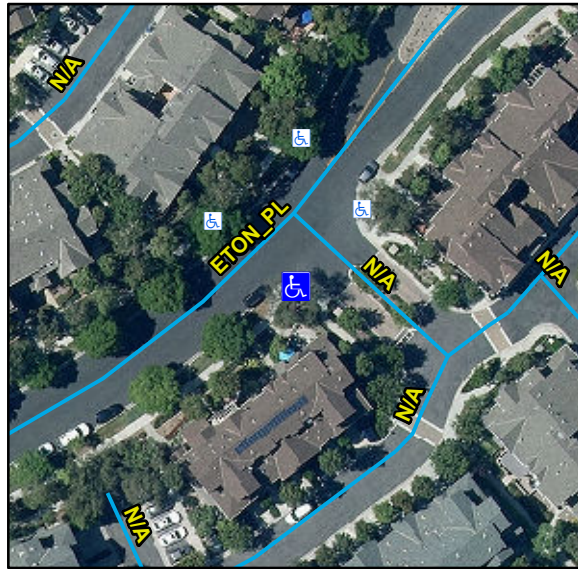
| Compliance | Description | Data | Compliance | Description | Data |
|---|---|---|---|---|---|
| Yes | Ramp Cross Slope LT (%) | 0.5 | No | Ramp Cross Slope RT (%) | 2.6 |
| No | Landing Width (in) | N/A | N/A | DWS Length (in) | N/A |
| No | Landing Run Slope (%) | N/A | N/A | DWS Full Width | N/A |
| No | Landing Cross Slope (%) | N/A | | DWS Offset Type | N/A |
| No | Gutter Run Slope (%) | 6.3 | | Road Cross Slope (%) | 1 |
| No | Gutter Cross Slope (%) | 3.7 | No | Perpendicular Joint Present | No |

Remove & Replace Curb Ramp With Two New Directional Ramps or Equivalent. Remove & Replace Gutter.
