# Access Compliance Report Public Rights-of-Way (Curb Ramps)

Main Street: TRIAD\_LN Cross Street: ETON\_PL Location: NW

ADA ID: RPRK211028121017 Ramp Type: Type 1 - Perpendicular Initial Pass/Fail: Fail Overall Compliance: No Severity Score: 16

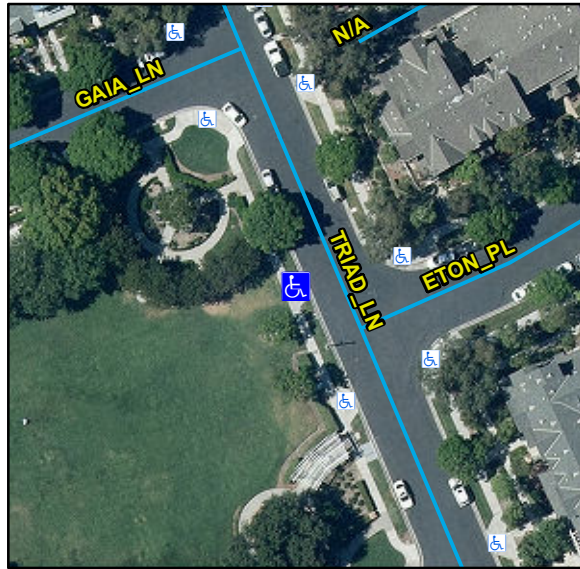
| Compliance | Description | Data | Compliance | Description | Data |
|---|---|---|---|---|---|
| No | Ramp Run Slope (%) | 10.9 | N/A | Flare Slope LT (%) | N/A |
| No | Ramp Cross Slope (%) | 4.2 | N/A | Flare Traversable LT | N/A |

Remove & Replace Entire Ramp.

R304.2.2, R204.3, R304.5.3, STD 1115
