# Access Compliance Report Public Rights-of-Way (Curb Ramps)

| Main Street: TRIAD_LN | | Cross Street: ETON_PL | | Location: | SW |
| ADA ID: RPRK211028121128 | Ramp Type: Type 1 - Perpendicular | Initial Pass/Fail: Fail | Overall Compliance: No | Severity Score: | 16 |

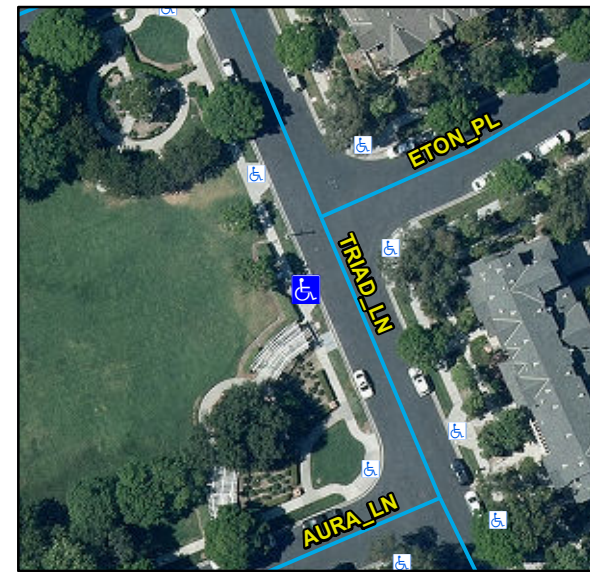
R304.2.2, R204.3, R304.5.3, STD 1115

| Compliance | Description | Data | Compliance | Description | Data |
|---|---|---|---|---|---|
| No | Ramp Run Slope (%) | 11.5 | N/A | Flare Slope LT (%) | N/A |
| No | Ramp Cross Slope (%) | 2.2 | N/A | Flare Traversable LT | N/A |

Remove & Replace Entire Ramp.

Total Cost: \$ 3080
